**Flood Control Project Maintenance
Levee Inspections**

Maintenance Issue Types Only, Levee Inspection Report By Mile - Fall 2019

Reclamation District No. 2035 Conaway

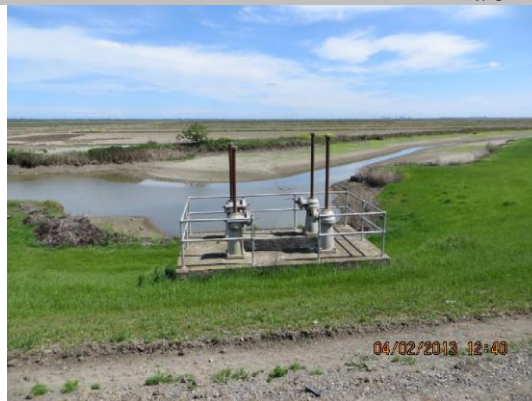
Photo 1 of 3 : UCIP_FA_2019_10933_18226.jpg

Slide gates in concrete vault on WS slope.

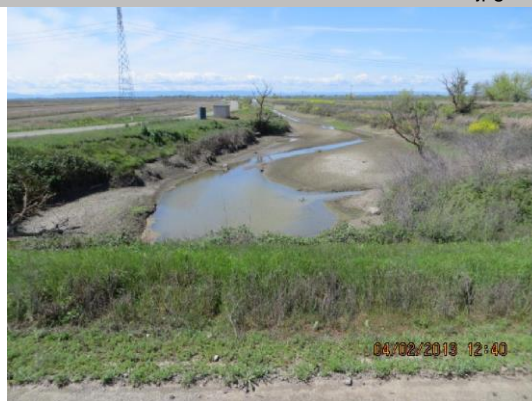
Photo 2 of 3 : UCIP_FA_2019_10933_18225.jpg

LS at intake.

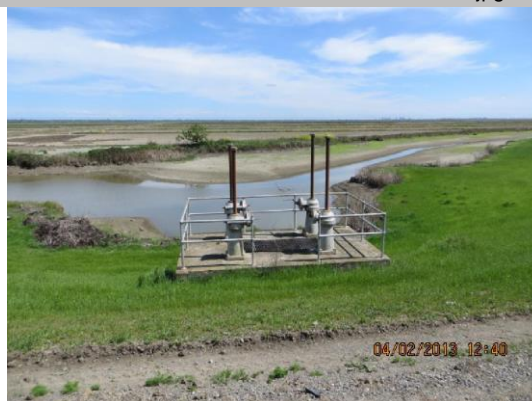
Photo 1 of 3 : UCIP_FA_2019_10934_18230.jpg

Slide gates in concrete vault on WS slope.

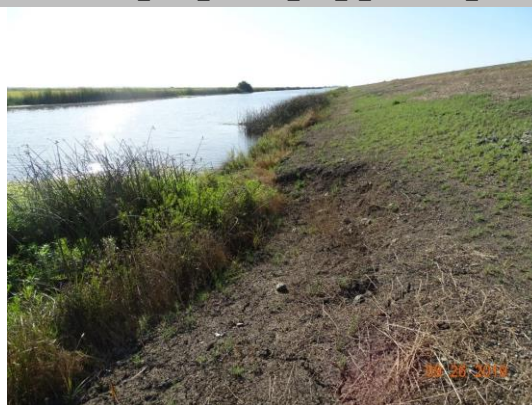
Photo 1 of 1 : FA_2019_RD2035_239_9_20190926_00028.jpg

LM Start	2.91	Rating **	M	Issue No.	9
LM End	2.91	Issue Type +	Ma	Location *	WS
Category	Earthen Levee			GPS Latitude/Longitude	
				Start	End
Item	Erosion / Bank Caving			38.637048 °	38.637048 °
				-121.659227 °	-121.659227 °
DWR ID	DWR_RD2035_02_f_2019_9				
Comment Code					
E2 : Schedule repair of erosion site prior to the next inspection.					
Inspector Comment					
Appears to be a 15' wide section of bank caving near the waterside toe. Recommend repairing.

View of bank caving on the waterside slope. Fall 2019.

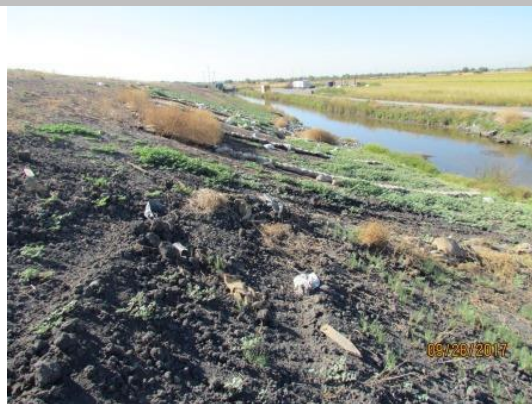
Photo 1 of 4 : FA_2019_RD2035_239_31_20190829_00002.jpg

LM Start	6.35	Rating **	A/W	Issue No.	31
LM End	6.38	Issue Type +	Ma	Location *	LS
Category	Supplemental			GPS Latitude/Longitude	
				Start	End
Item	2017 Storm Damage			38.592840 °	38.592390 °
				-121.631340 °	-121.631320 °
DWR ID	RD 2035-08				
Comment Code					
Inspector Comment					
Levee Evaluation Comments					
Description:					
Site ID No:195					
Site Designation:RD 2035-08					
Repair Type: Erosion					
Rating:Critical					
Field Date:7/13/2017					
Notes: long longitudinal cracks on the crown. Scheduled for repair in 2020.

View of the damaged landside slope. Fall 2017.

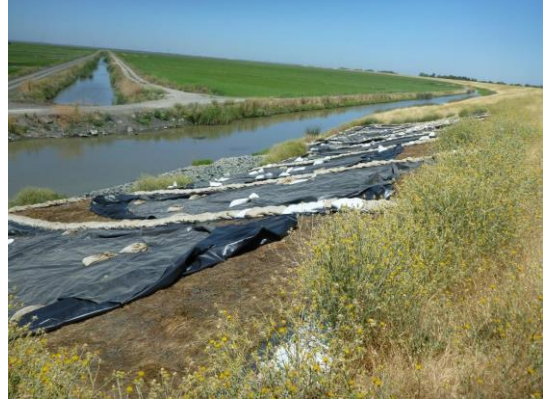
Photo 2 of 4 : LEVAL_FA_2019_195_1600.jpg

LM Start	6.35	Rating **	A/W	Issue No.	31 (cont)
LM End	6.38	Issue Type +	Ma	Location *	LS
Category	Supplemental			GPS Latitude/Longitude	
				Start	End
Item	2017 Storm Damage			38.592840 °	38.592390 °
				-121.631340 °	-121.631320 °
DWR ID	RD 2035-08				
Comment Code					
Inspector Comment					
Levee Evaluation Comments					
Description:					
Site ID No:195					
Site Designation:RD 2035-08					
Repair Type: Erosion					
Rating:Critical					
Field Date:7/13/2017					
Notes: long longitudinal cracks on the crown. Scheduled for repair in 2020.

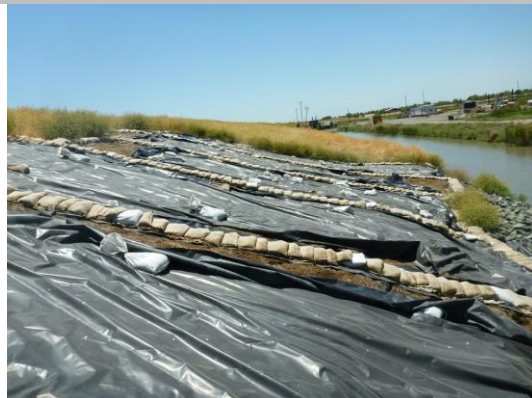
Photo 4 of 4 : LEVAL_FA_2019_195_1592.jpg

LM Start	6.35	Rating **	A/W	Issue No.	31 (cont)
LM End	6.38	Issue Type +	Ma	Location *	LS
Category	Supplemental			GPS Latitude/Longitude	
				Start	End
Item	2017 Storm Damage			38.592840 °	38.592390 °
				-121.631340 °	-121.631320 °
DWR ID	RD 2035-08				
Comment Code					
Inspector Comment					
Levee Evaluation Comments Description: Site ID No:195 Site Designation:RD 2035-08 Repair Type: Erosion Rating:Critical Field Date:7/13/2017 Notes: long longitudinal cracks on the crown. Scheduled for repair in 2020.

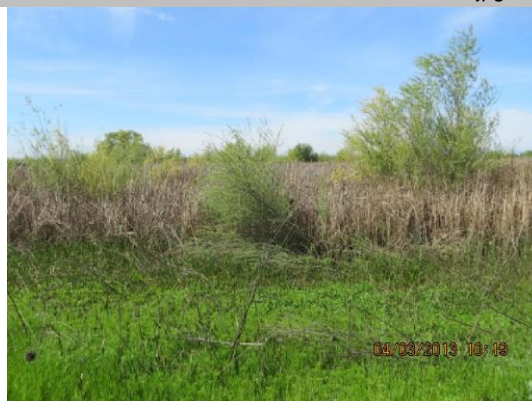
Photo 3 of 3 : UCIP_FA_2019_41128_18346.jpg

Vegetated area blocks access to WS of pipe.

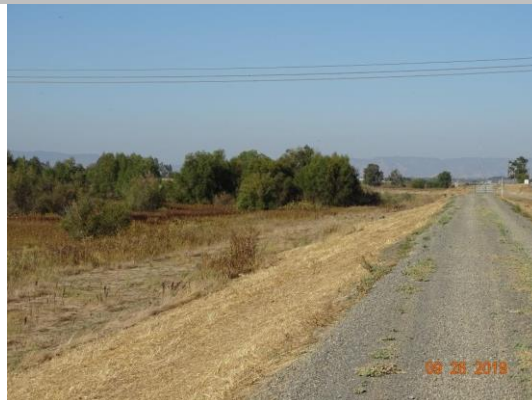
Photo 1 of 1 : FA_2019_RD2035_240_6_20190926_00015.jpg

LM Start	2.00	Rating **	A	Issue No.	6
LM End	2.00	Issue Type +	Ma	Location *	LS
Category	Earthen Levee			GPS Latitude/Longitude	
				Start	End
Item	Vegetation			38.591010 °	38.591010 °
				-121.655862 °	-121.655862 °
DWR ID	DWR_RD2035_03_f_2019_6				
Comment Code					
V1 : Control annual grass and weeds on the levee slopes and easements.					
Inspector Comment					
The LMA maintains the vegetation at a high level.

View of the maintained landside slope. Fall 2019.

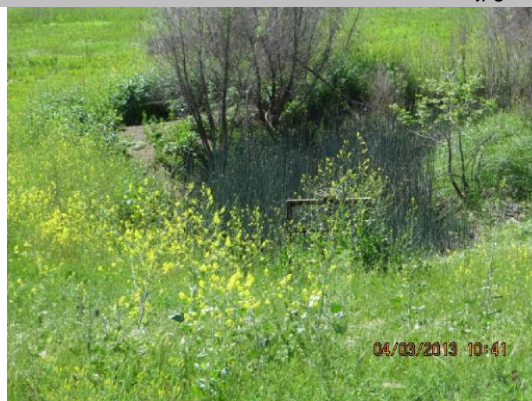
Photo 1 of 2 : UCIP_FA_2019_11011_18354.jpg

LM Start	2.17	Rating **	M	Issue No.	976	
LM End	2.17	Issue Type +	Ma	Location *		
Category	Supplemental			GPS Latitude/Longitude		
				Start	End	
Item	DRAFT DWR UCIP LMA Responsibility			38.590934 °	38.590934 °	
				-121.658940 °	-121.658940 °	
DWR ID	17837					
Comment Code						
Inspector Comment						
DS_ID:17837						
FS_ID:11011						
EP_NO: N/A						
Repair Type: Non-Urgent						
Crossing Status: Found						
UCIP Comments: 04/03/2013 Debris and vegetation partially blocking inlet and outlet at both toes. (W. Wylie - DWR UCIP)						
FIELD_STRUCT_DESC: 48-inch corrugated metal drainage pipe through the levee, 19 feet below the crown. Slide gates on both ends. [Additional Reference(s): DWR Levee Log, 1990. USACE Sacramento O&M Manual 120, June 1952, (Station 290+37)].						
FS Date: 4/3/2013

Slide gate at WS toe showing excessive vegetation.

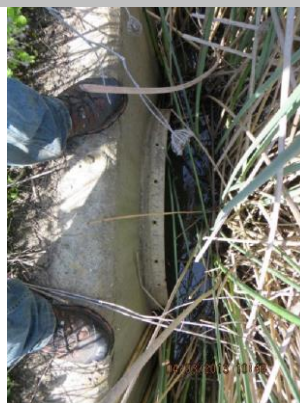
Photo 3 of 3 : UCIP_FA_2019_11012_18355.jpg

Headwall and pipe on LS toe.
